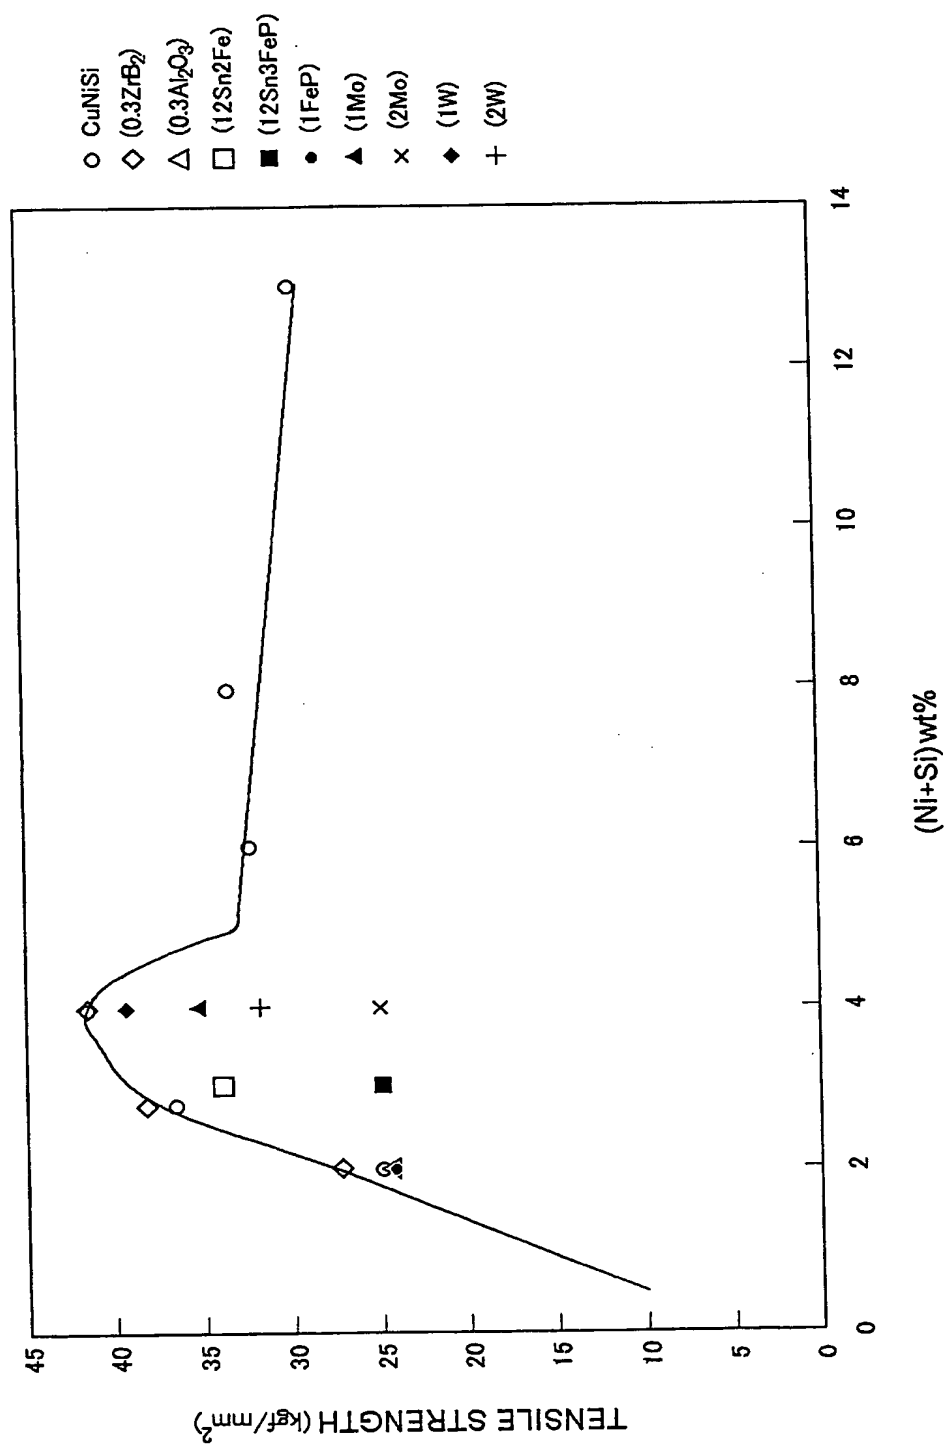
FIG. 2 THE TENSILE STRENGTH OF CuNiSi AND CuSnNiSi SINTERED MATERIALS (σ_b)

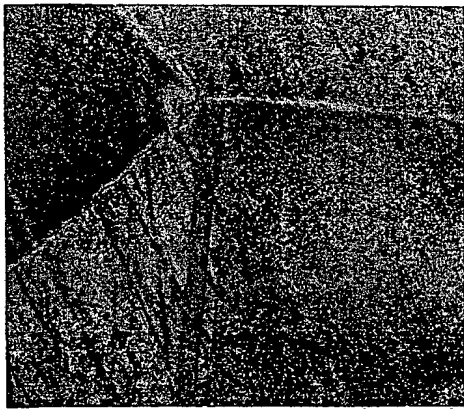
a) Cu-3Ni-1Si

THE STRUCTURES OF Cu-Ni-Si BASED SINTERED COMPACTS
(A MAGNIFICATION OF $\times 400$)
(SINTERING CONDITION $1100^{\circ}\text{C} \times 1\text{HR}$)
